## FINAL REPORT

HIMCO SITE  
 ELKHART, INDIANA

Prepared for: Himco Site Trust

**Conestoga-Rovers & Associates**  
 651 Colby Drive  
 Waterloo, Ontario N2V 1C2  
 Canada

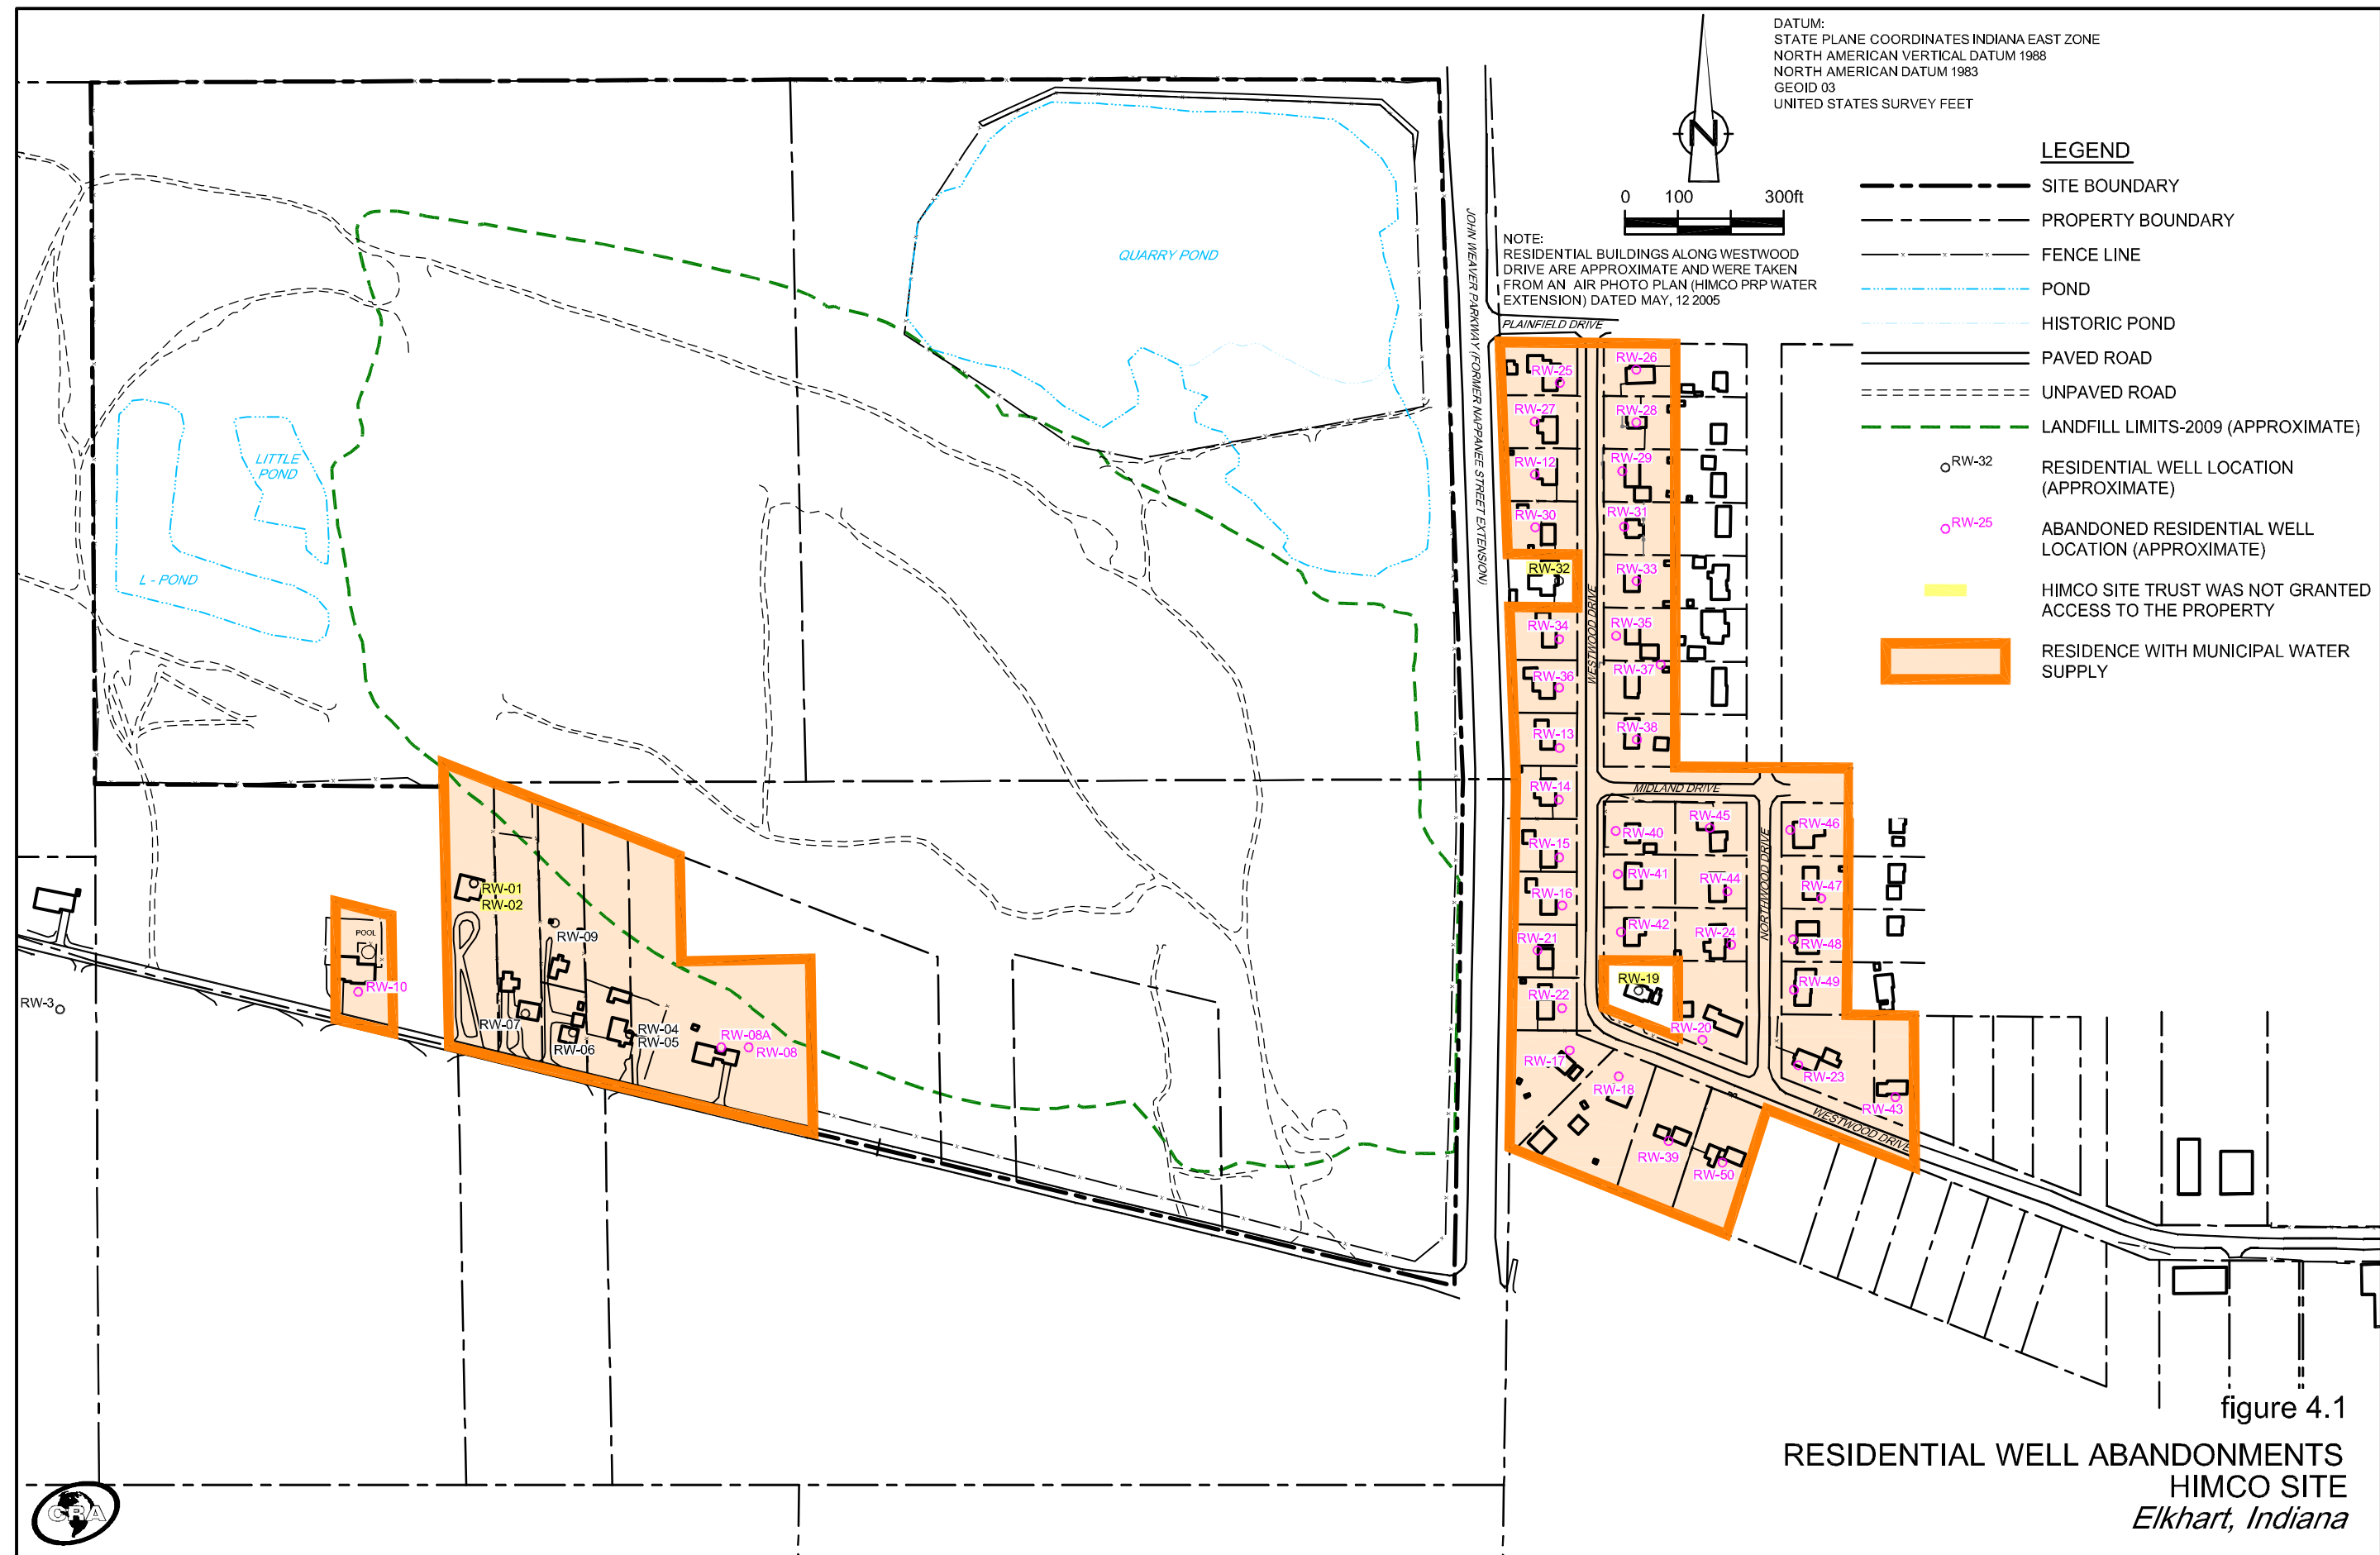
figure 4.1

RESIDENTIAL WELL ABANDONMENTS  
HIMCO SITE  
Elkhart, Indiana

Table 4.1 presents the list of residential water supply wells abandoned by the PSDs per the SOW. J.W. Bowles Well Drilling abandoned 37 residential wells east of the Site in December 2009, and Stearns Drilling abandoned three wells south of the Site in July 2012. The approximate location of the abandoned wells is shown on Figure 4.1. The type and depth of well found at each location is summarized in Table 4.1.

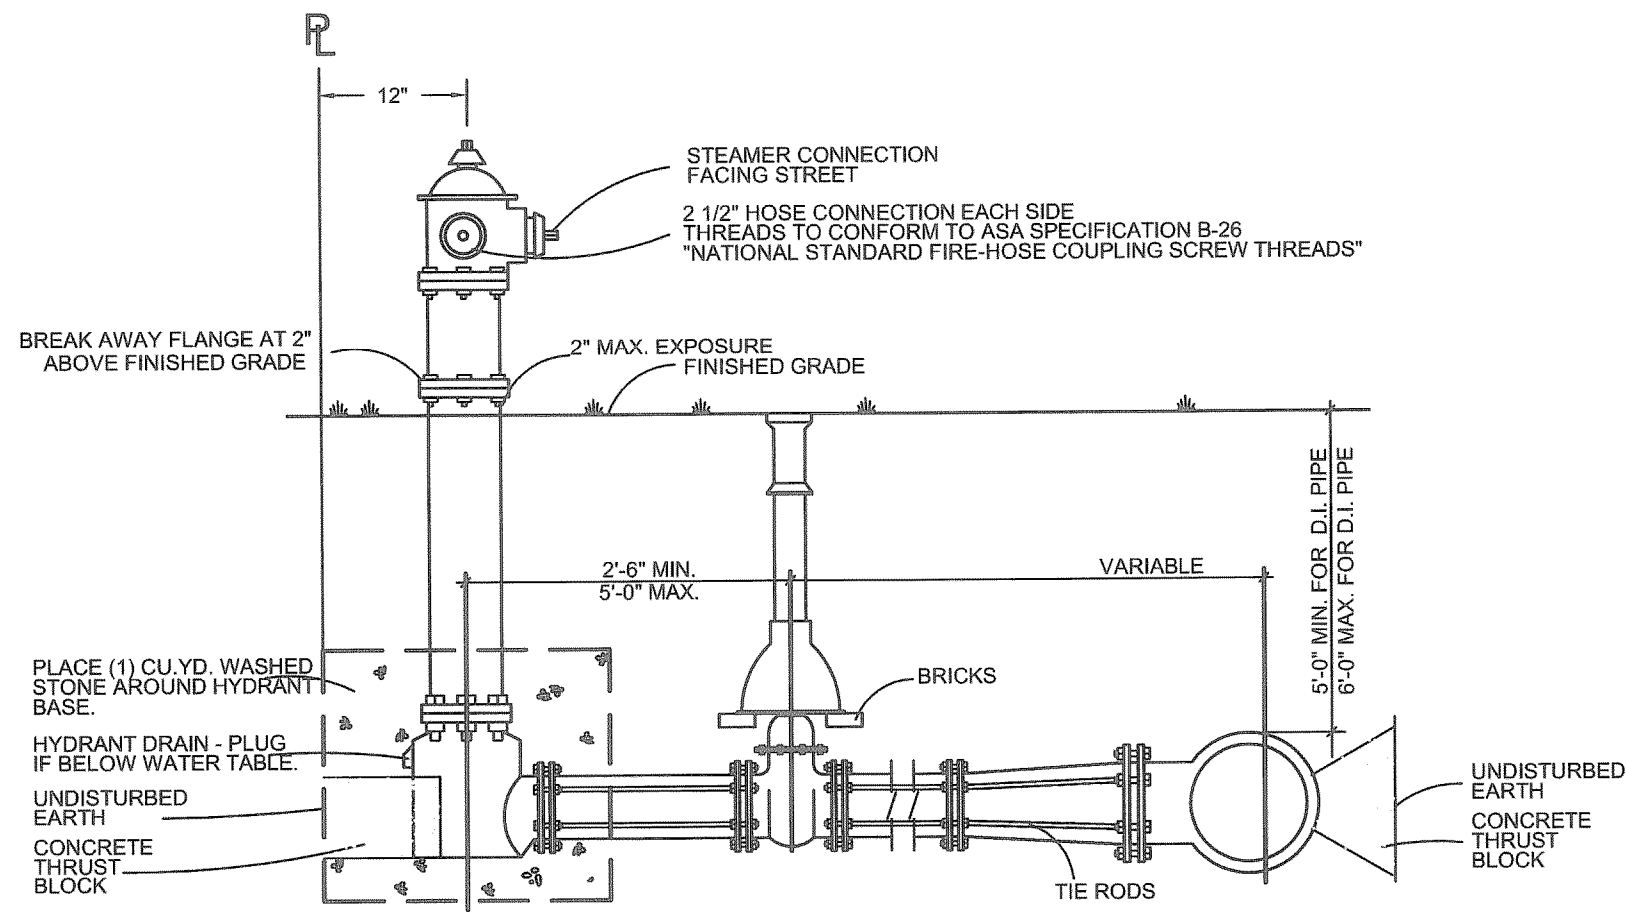
DETAIL 1 TYPICAL HYDRANT ASSEMBLY  
N.T.S.

- APPROVED ASSEMBLIES:
- EAST JORDAN IRON WORKS BR5
  - CLOW MEDALLION
  - MUELLER SUPER-CENTURION
  - US PIPE HYDRANT
- NOTE: HYDRANT TO MEET AWWA STANDARD C-502, AND CITY OF ELKHART WATERWORKS STANDARDS

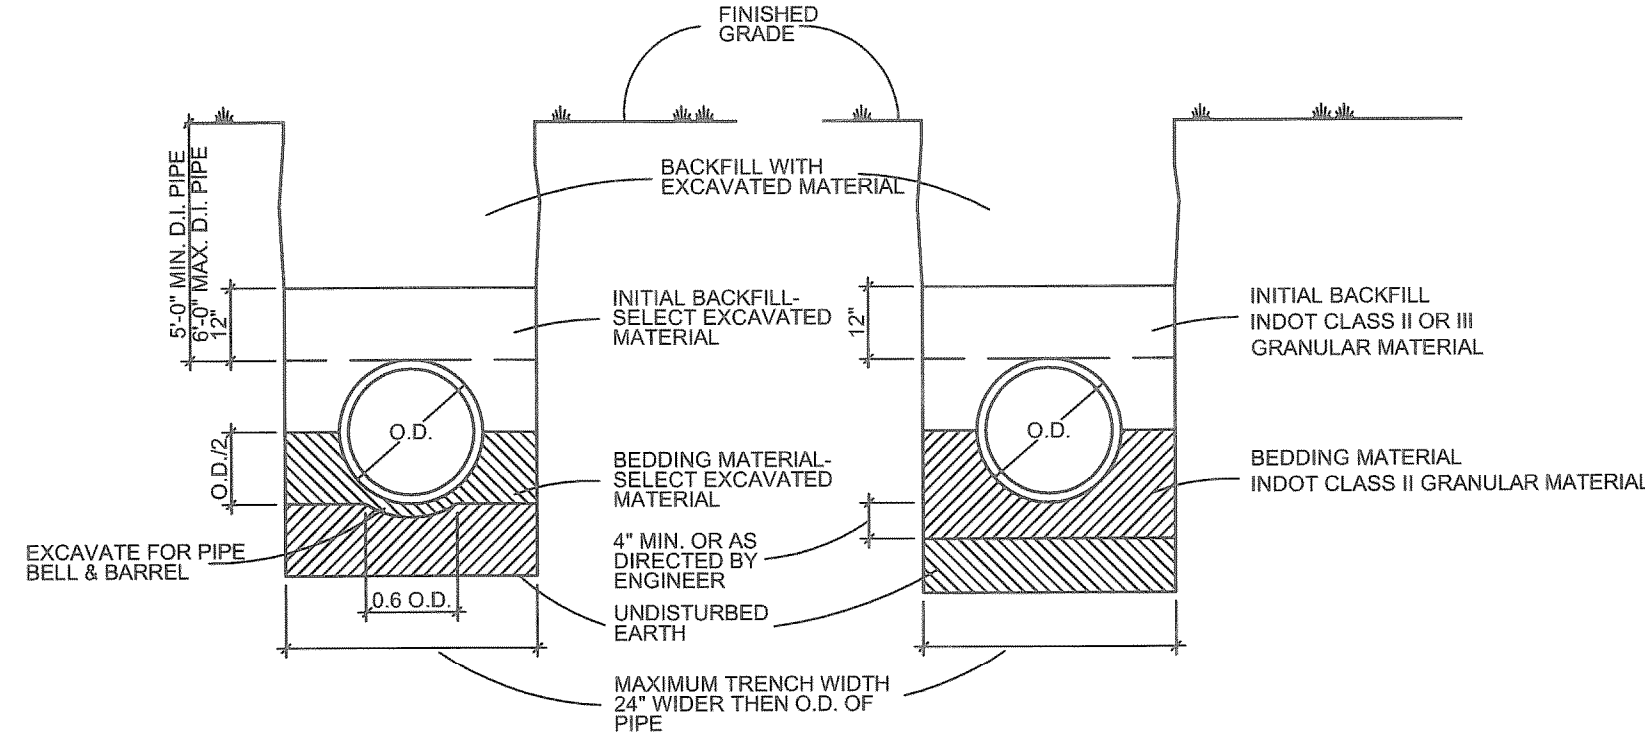
DETAIL 2 TRENCH INSTALLATION  
N.T.S.

SUITABLE SOIL      UNSUITABLE SOIL

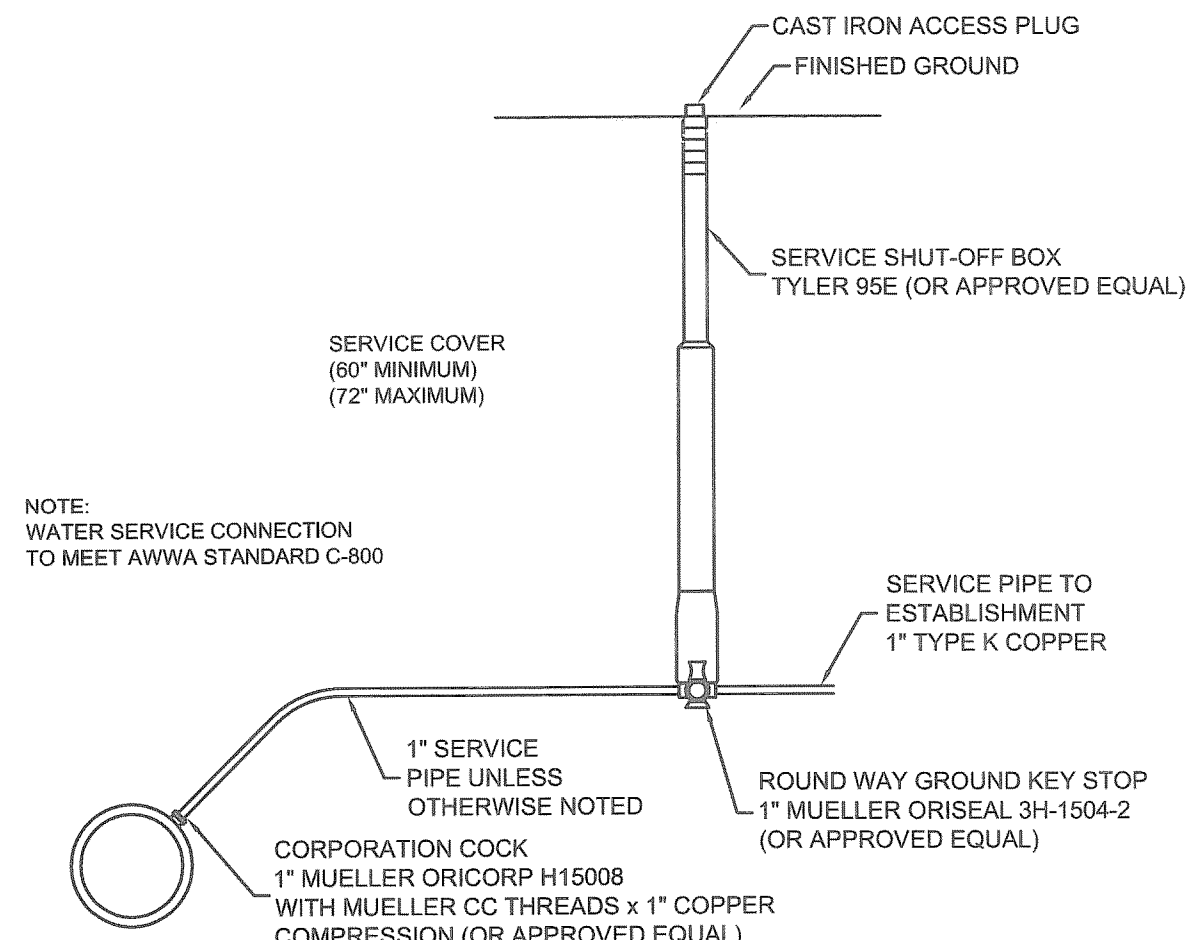
DETAIL 5 WATER SERVICE CONNECTION  
N.T.S.

NOTE: WATER SERVICE CONNECTION TO MEET AWWA STANDARD C-800

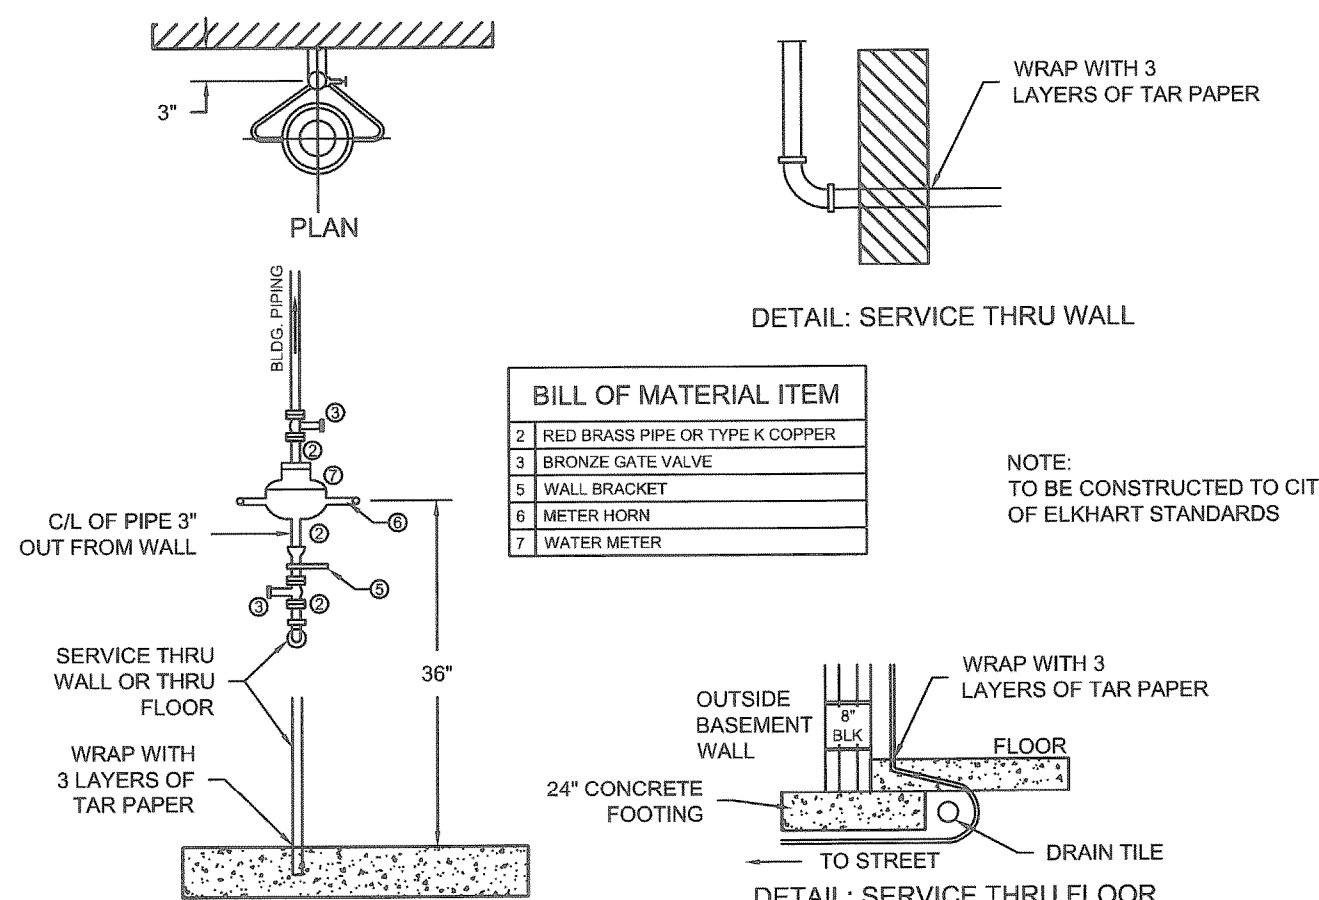
DETAIL 7 SERVICE CONNECTION TO RESIDENCE  
N.T.S.

NOTE: TO BE CONSTRUCTED TO CITY OF ELKHART STANDARDS

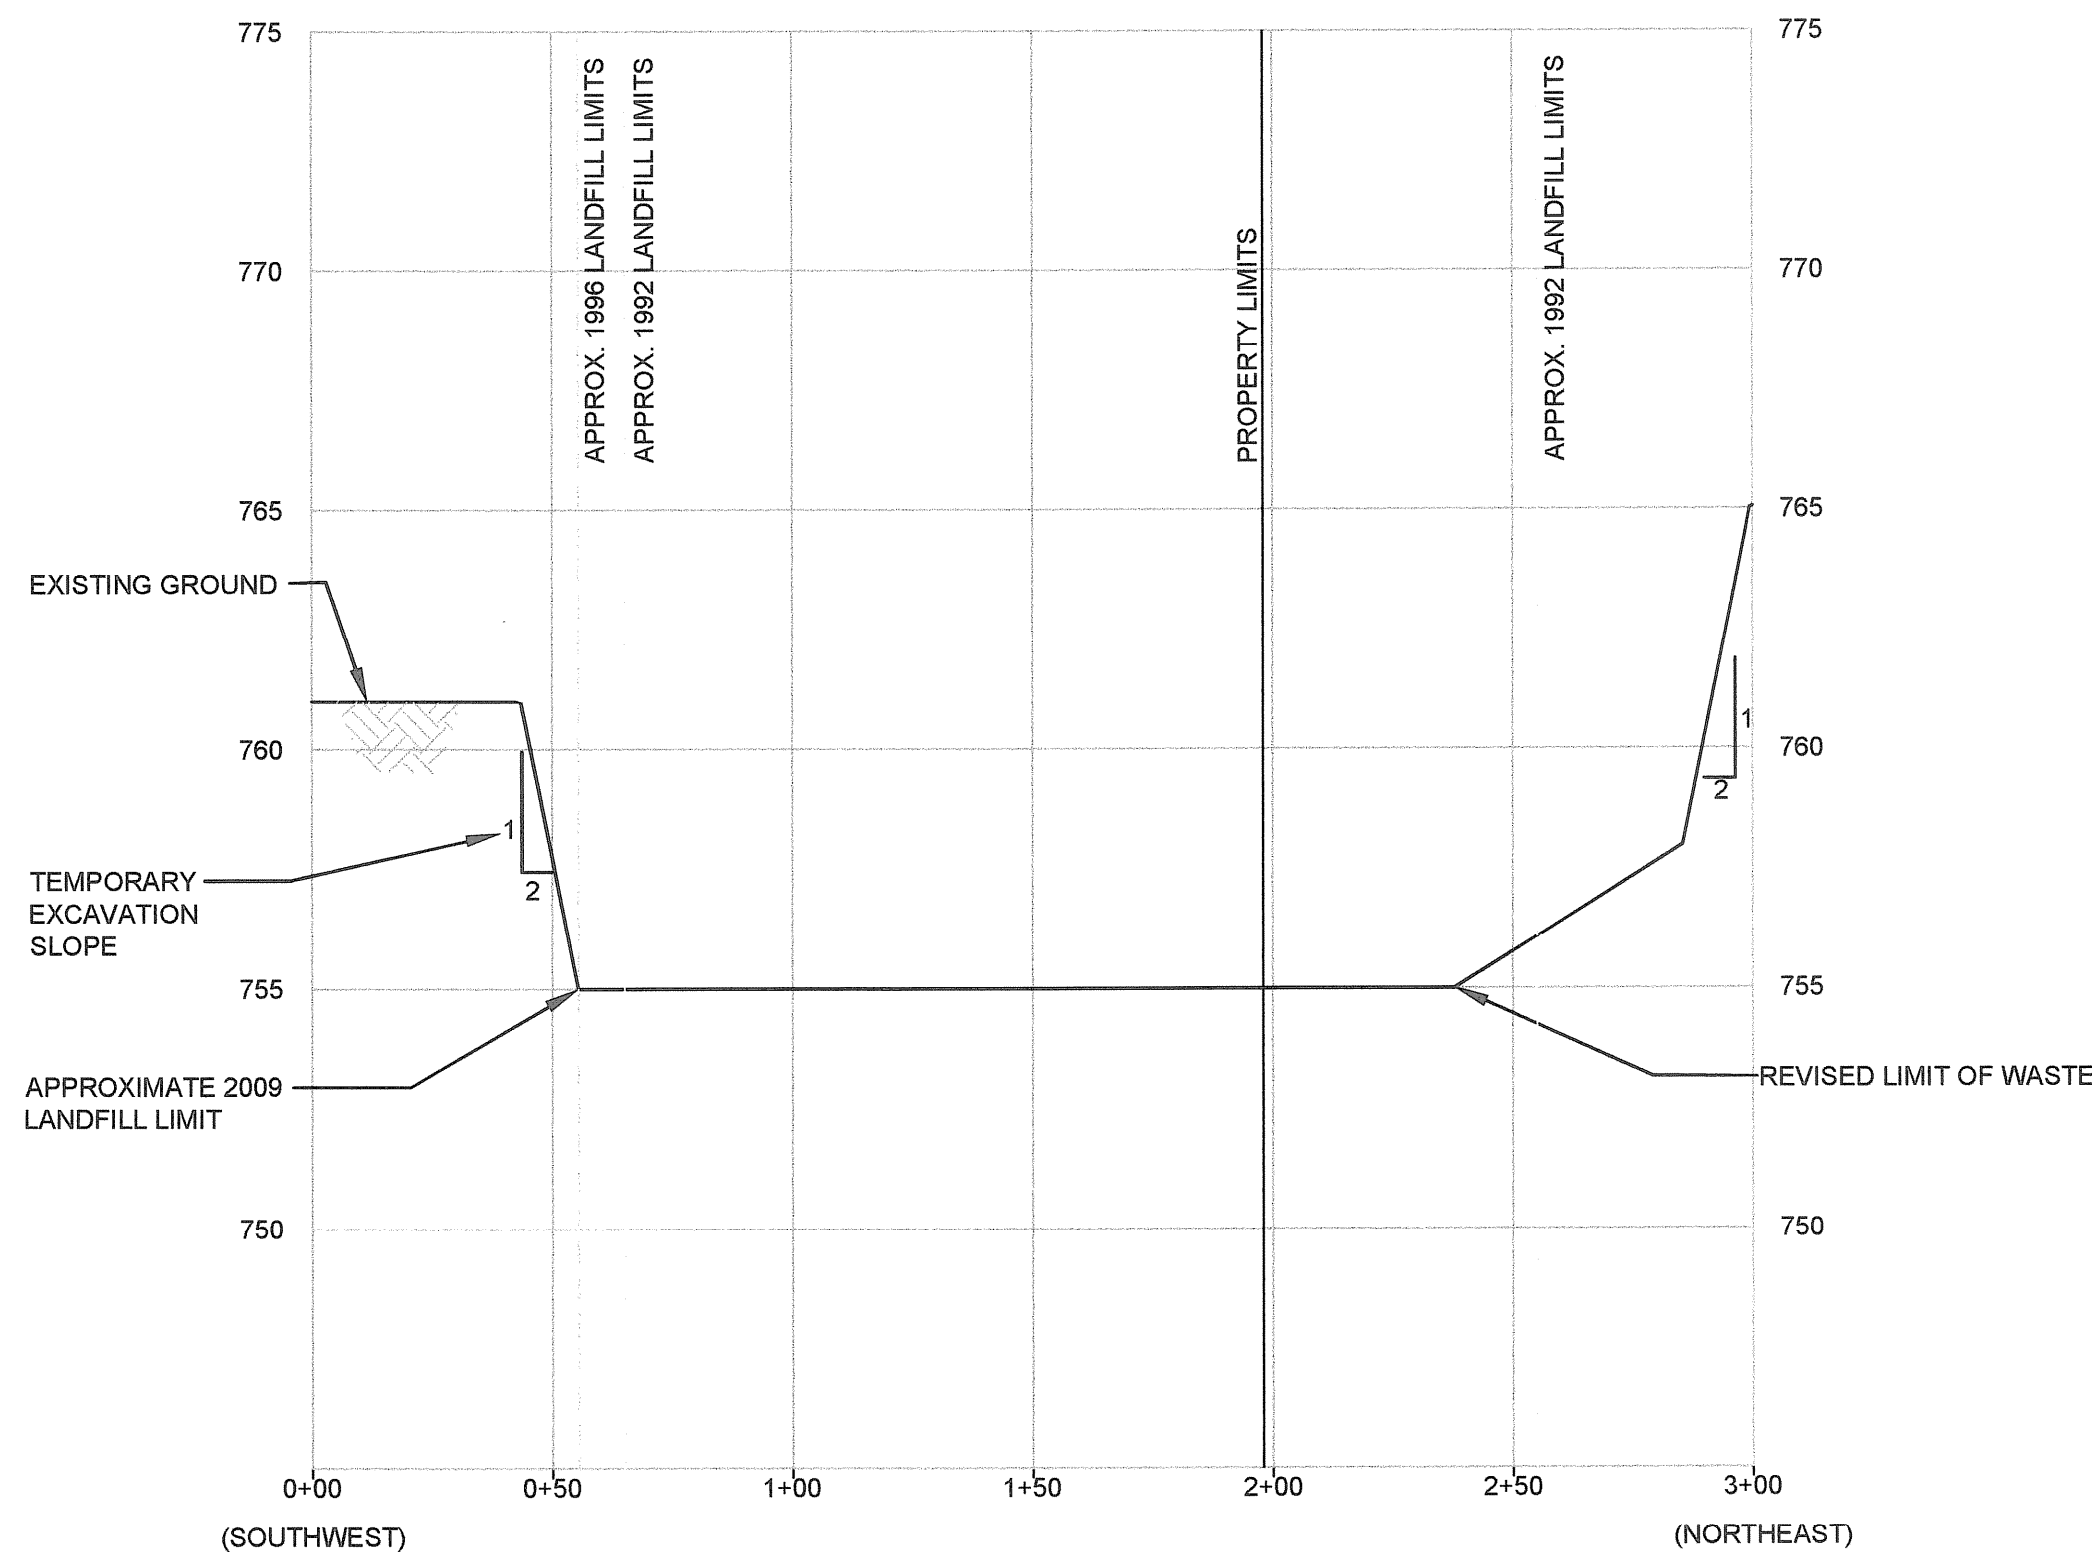
**SECTION B-B**

**SOUTH EXCAVATION AREA**

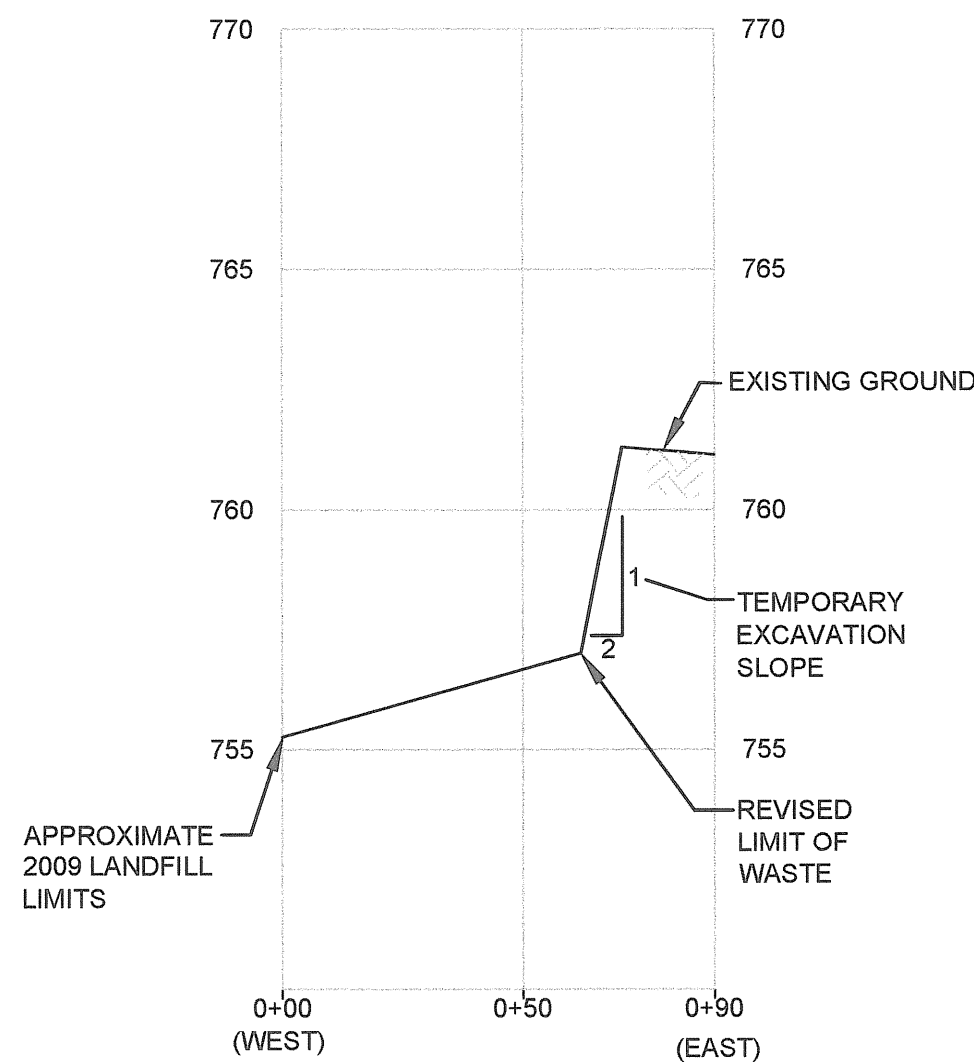
**SECTION C-C**

**WEST EXCAVATION AREA**

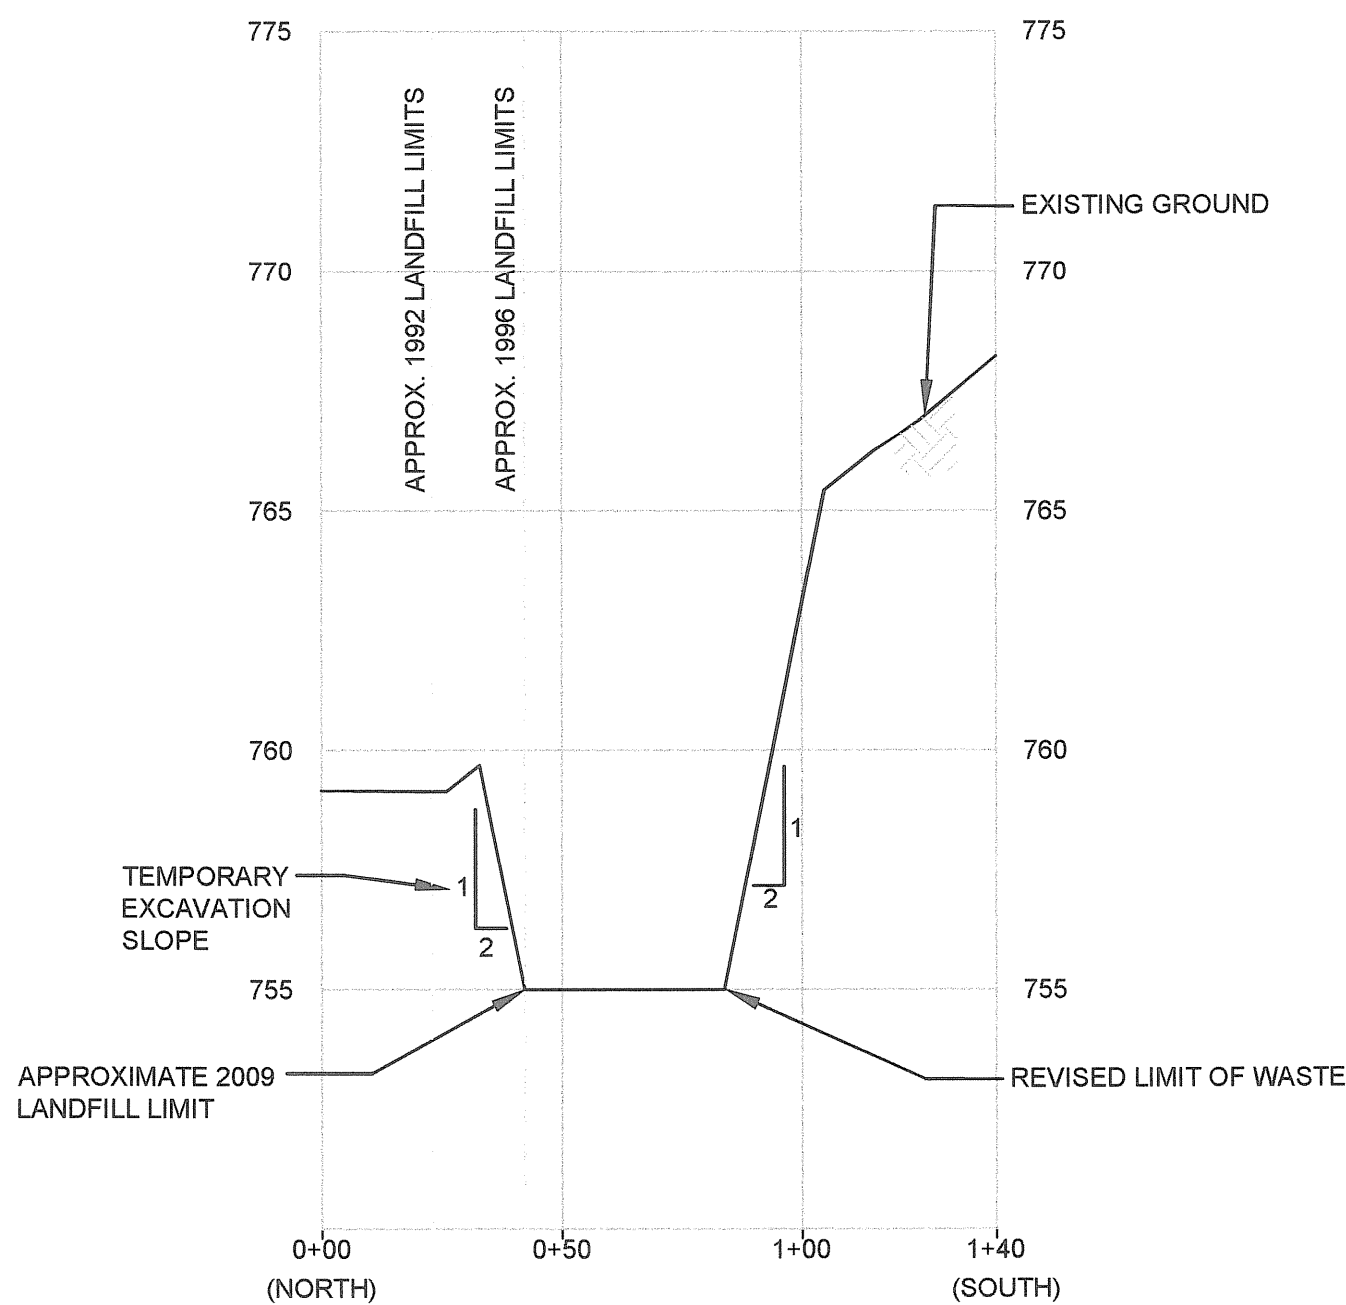
**SECTION D-D**

**NORTHWEST EXCAVATION AREA**

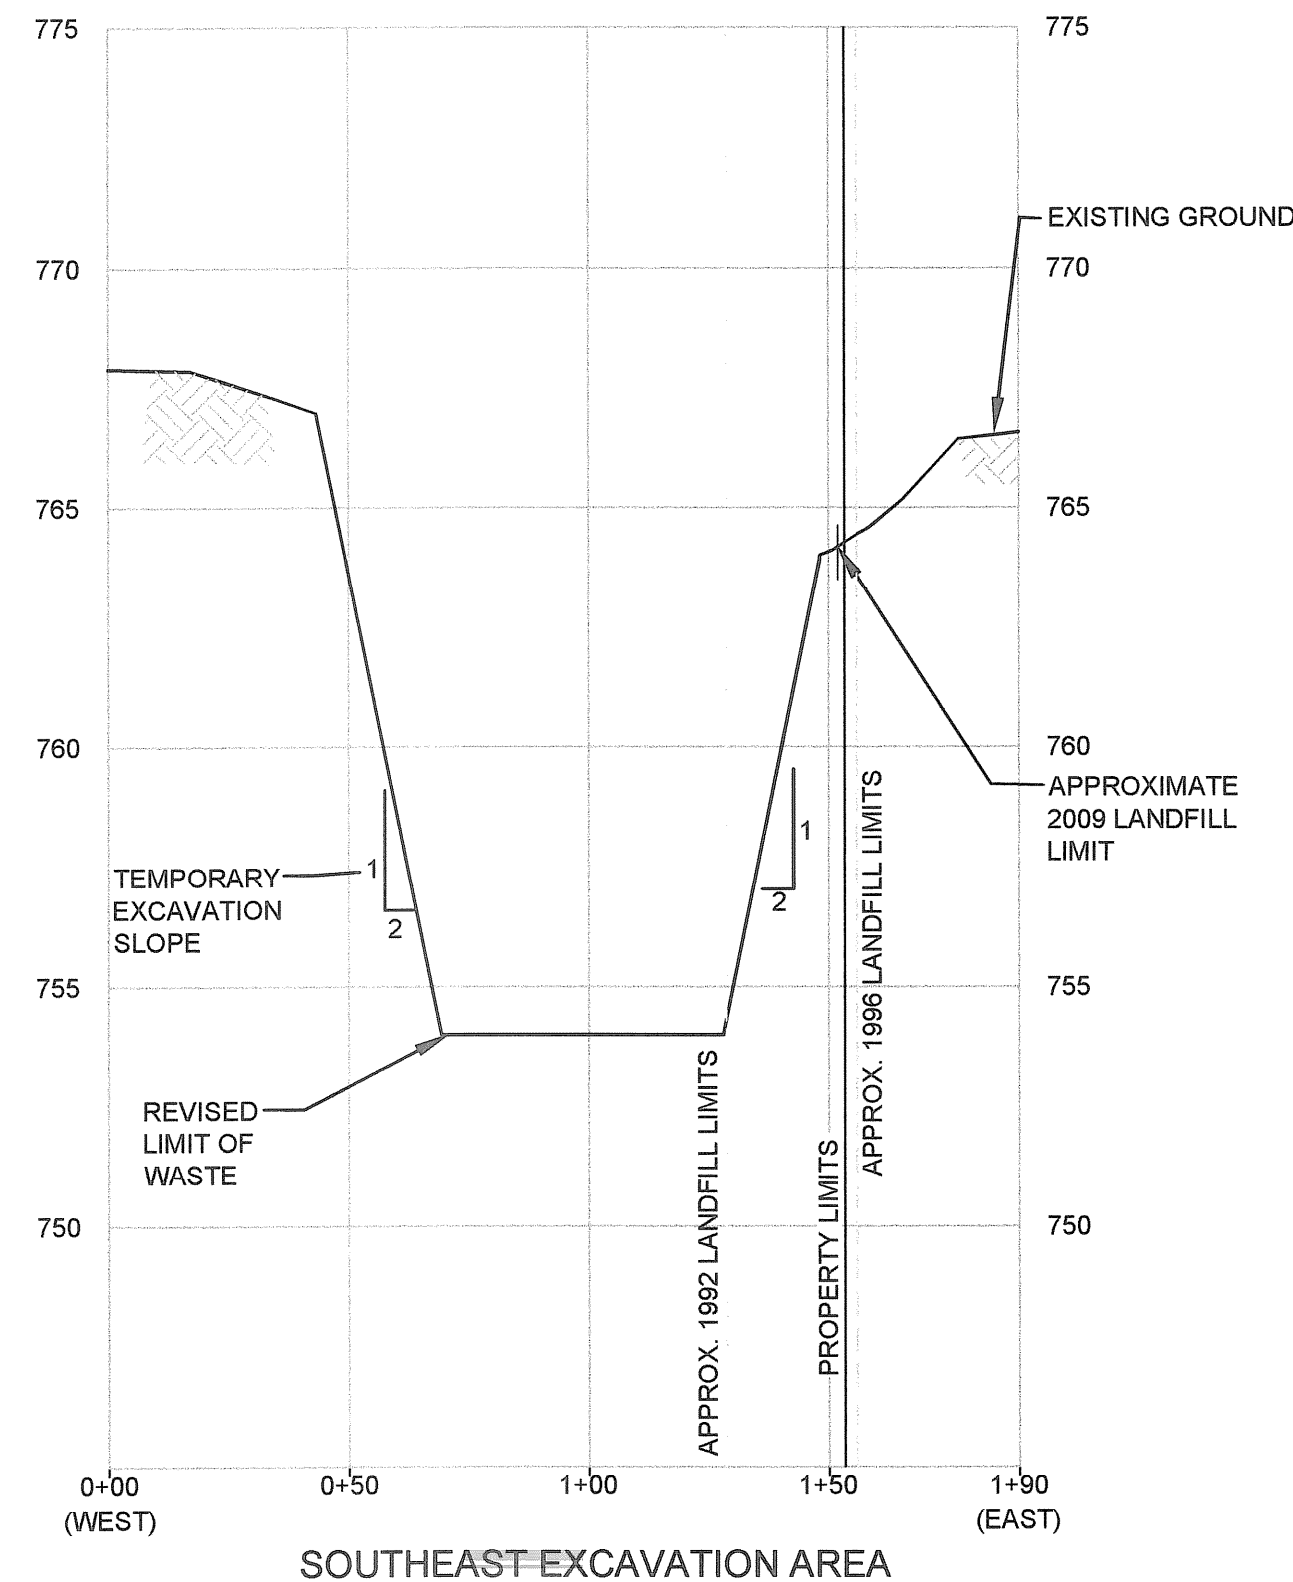
**SECTION A-A**

**SOUTHEAST EXCAVATION AREA**

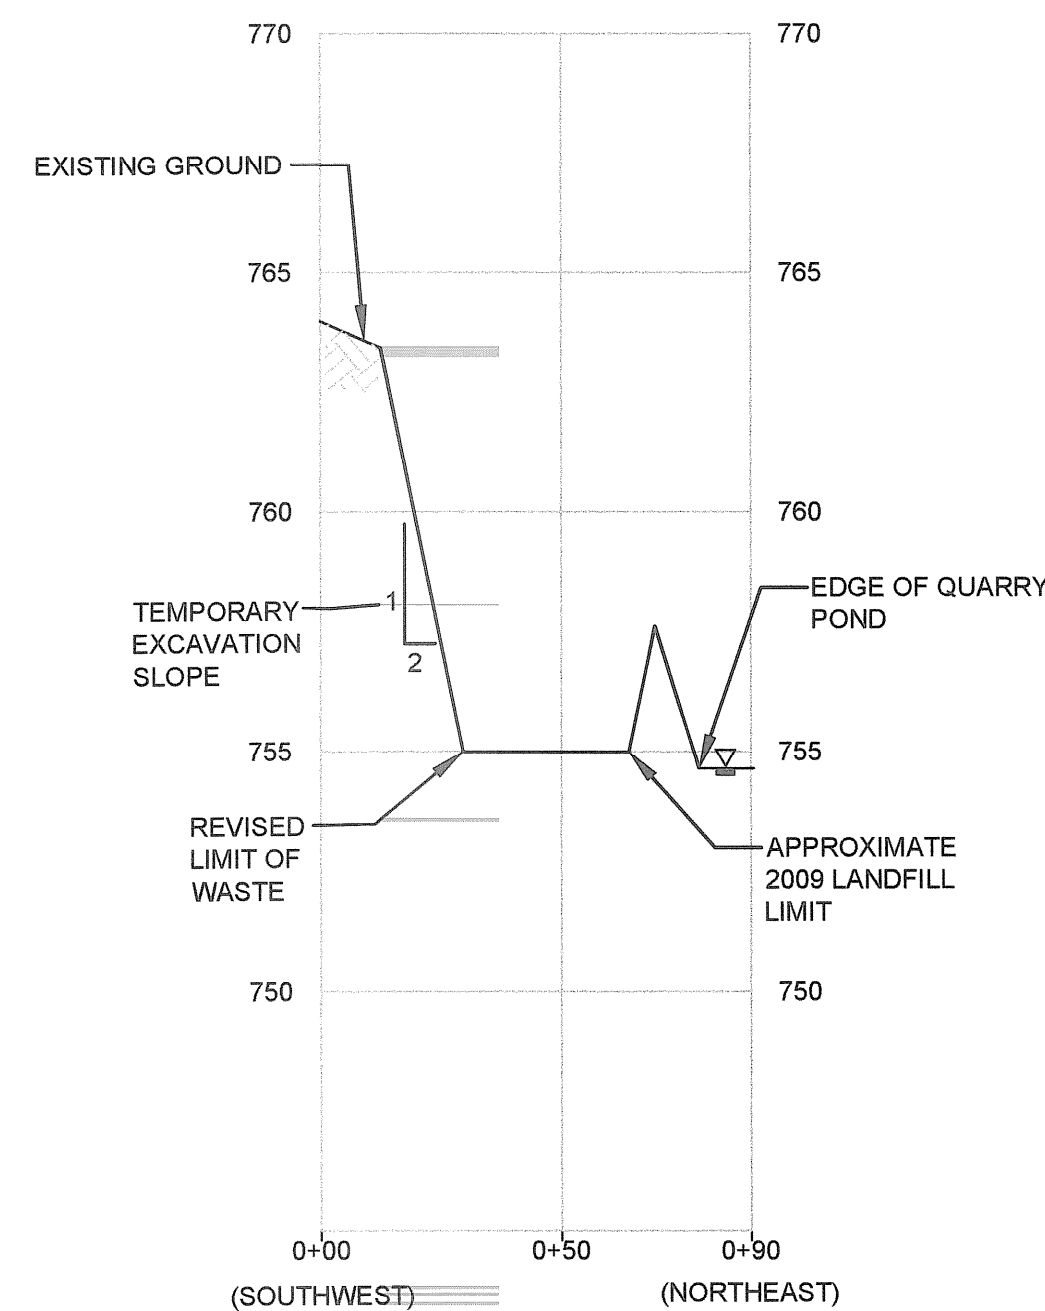
**SECTION E-E**

**NORTHEAST EXCAVATION AREA**

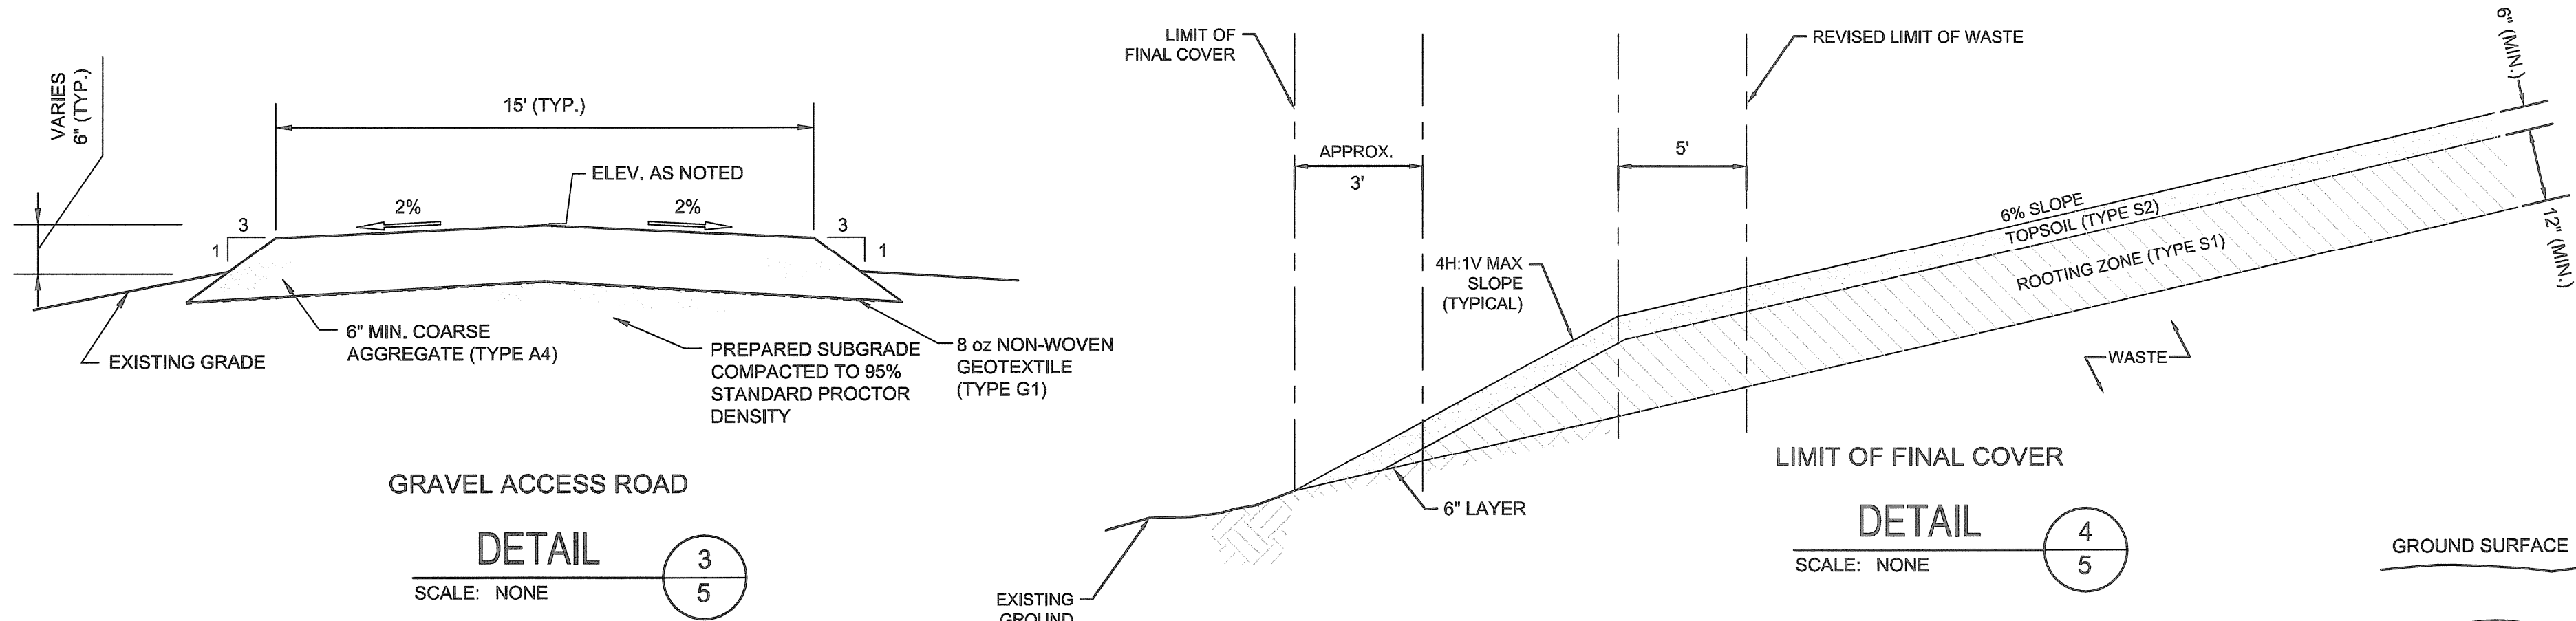
DETAIL 3

GRAVEL ACCESS ROAD

CRA also adapted the design of the access roads to match existing Site conditions. Each of these design changes are discussed in this Report. The as-built details are recorded on the Record Drawings, attached to this Report.

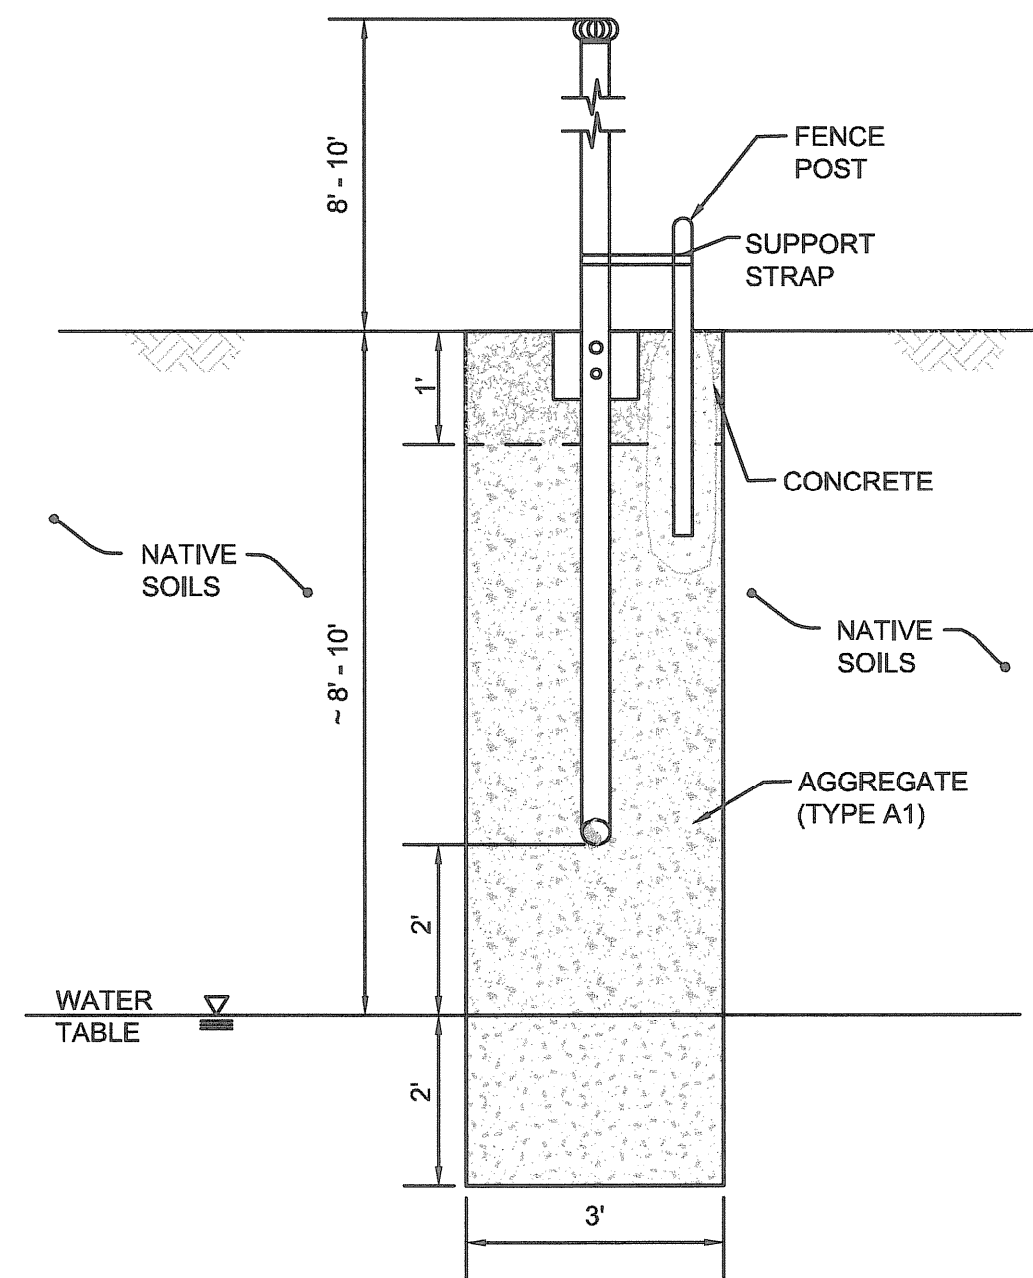
DETAIL 5

TYPICAL PASSIVE VENTILATION TRENCH (SECTION)

NOTE: 2" SCH 40 PVC RISER NOT SHOWN FOR CLARITY.
